D&D of a Former Beryllium Machine Shop

Gary E Whitney, CIH
Industrial Hygiene & Safety Division
Los Alamos National Laboratory

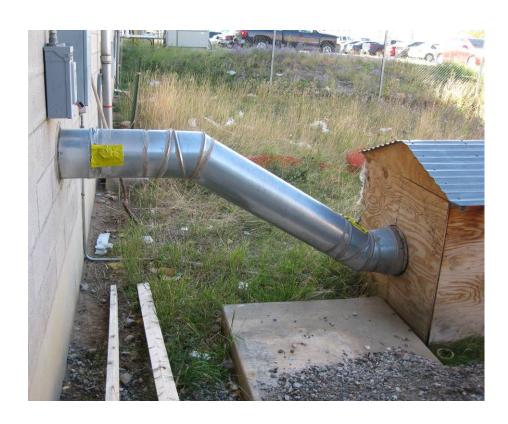
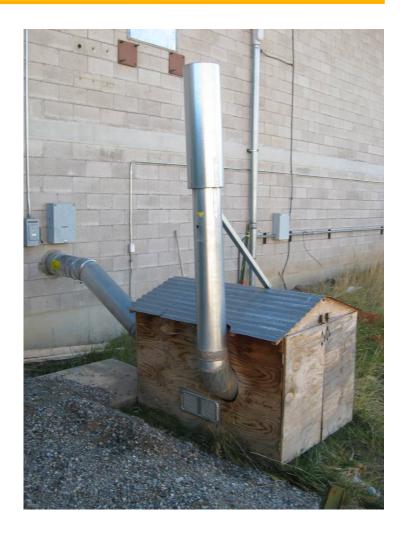
Supplemental Exterior Ventilation

- A problem with the dynamic precipitator in 2000 required a ventilation system shutdown for repairs.
- Ventilation system normally on 24/7 to keep shop negative in respect to hall. Concerns of contamination spread.
- Solution was a HEPA clean-air machine (~800 cfm)
 installed outside building and connected via a duct through
 the wall.
- This additional ventilation was not installed as part of this project, but it certainly provided an advantage and should be considered for similar jobs.

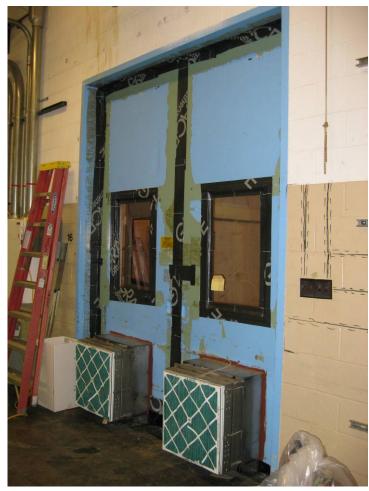
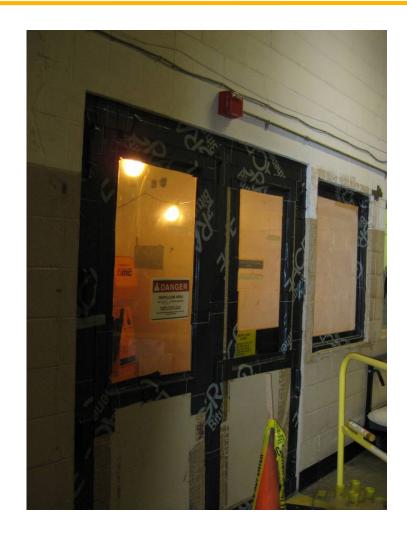
Sealing Shop Doors and Windows

- When in operation the beryllium machine shop had daily cleaning; routine surface wipe samples were collected; ventilation system was checked daily; and air samples were collected for all machining operations.
- All this served to constantly monitor the situation and control contamination spread.
- Concerns were raised over how to maintain control when the shop was no longer operational and unoccupied.
- Chosen solution was to seal in the shop.

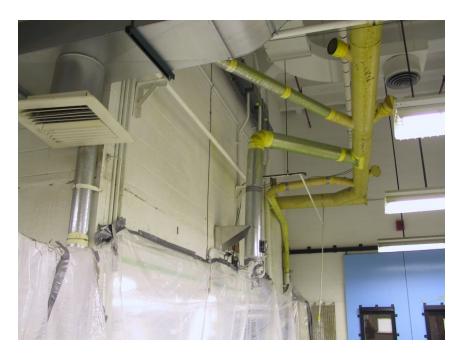
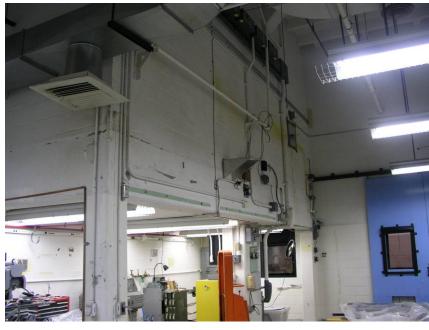
Phase I: Remove the Ductwork

Before Phase I

After Phase I

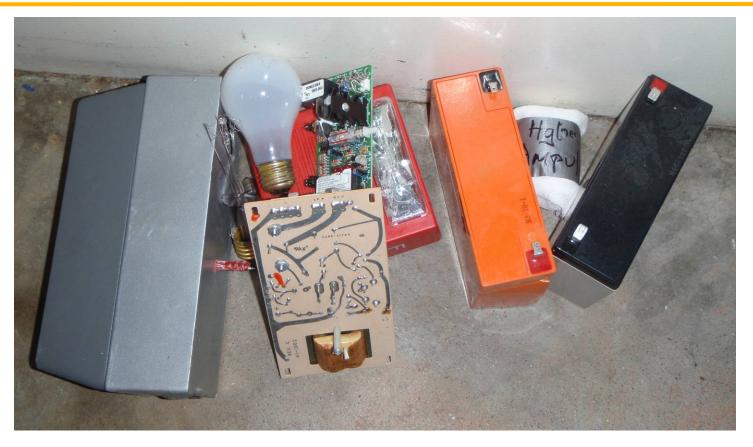
Issue: Keeping Waste Streams Separate

- Machines may contain unexpected subcomponents.
- Required transportainer "dumpster diving" and re-packing.

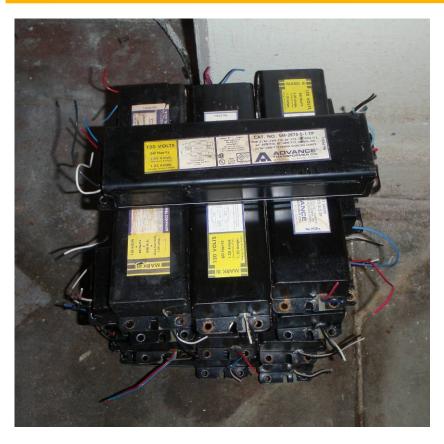
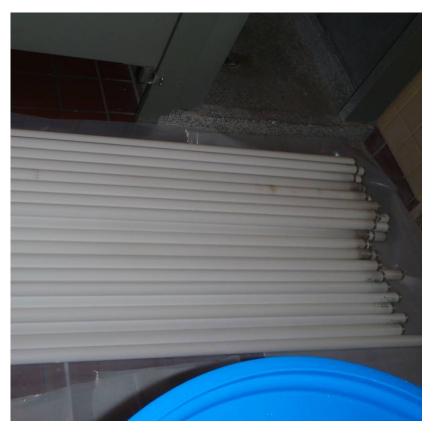
Issue: Keeping Waste "Clean"

- Hazardous wastes had separate disposal pathways.
- Decontamination of surfaces required before disposal.

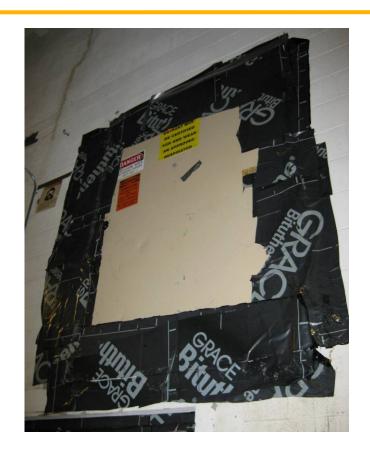
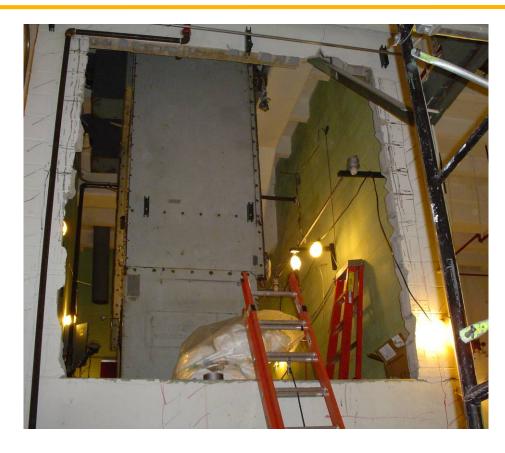
Solution: Keep Door Sealed; Knock Out Wall

- The only mezzanine access was through an elevated door that opened onto a platform above the north wing hallway.
- The narrow metal platform and ladder were removed during an earlier ventilation system repair and replaced with a temporary platform and stair.
- During Phase I workers accessed mezzanine through the hallway door. Workers exited the space through a buffer area that allowed doffing outer PPE.
- Not considered acceptable for Phase II. No materials out through hallway.

- Door to hall remained sealed.
- Knock out back wall of mezzanine into shop.
